# Plant Community Response to Vegetation Treatments on a Columbia Gas Pipeline Right-of-Way

Ohio State University-Mansfield Ecolab and Ohio Woodlands Stewards Report

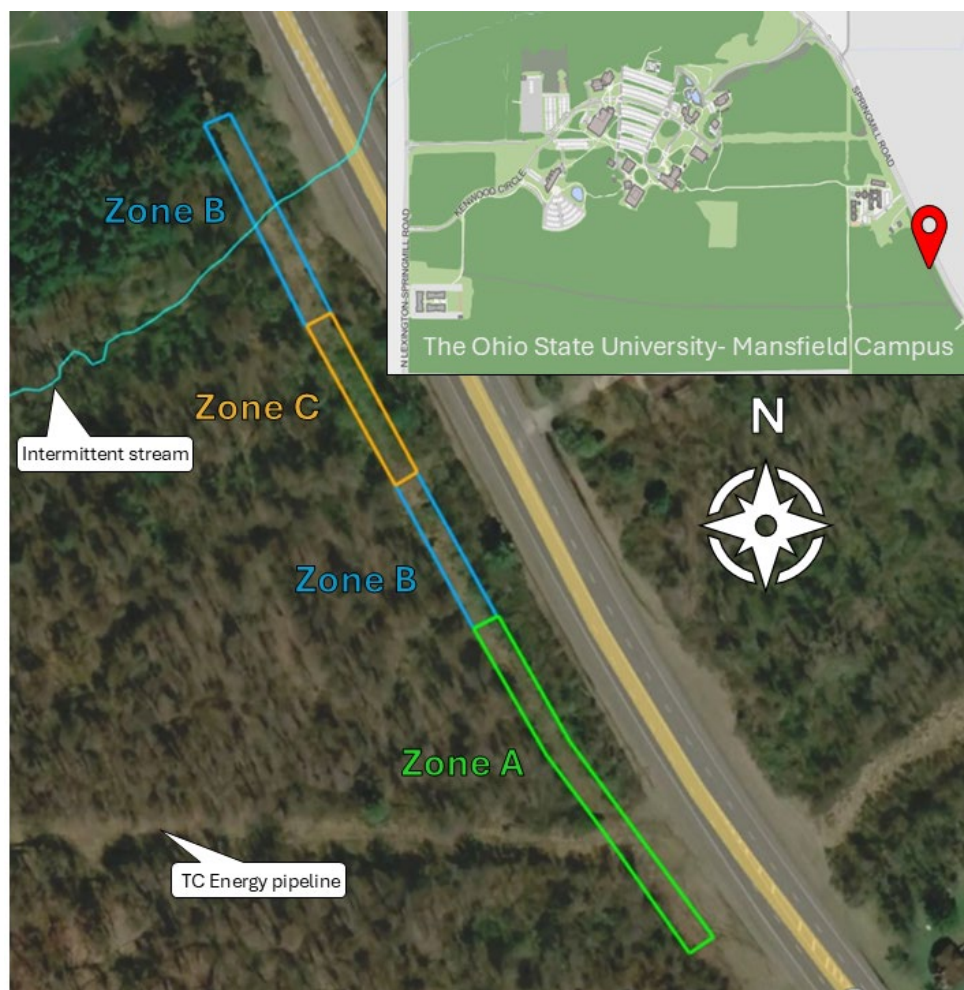
Figure 1. Map of Zones A, B, and C.

post- treatment. To date, the Ecolab has collected 11 months of data over four different years. Monitoring takes place on a 300-meter stretch, where three different treatments are compared (Figure 1). The west side of the ROW is surrounded by a contiguous deciduous forest minus a small stand of conifers at the end of Zone B, and to the east a thin strip of forest separates the ROW from a state route highway. Due to this close proximity, a small section of Zone A has regularly been included in the roadside mowing that the Ohio Department of Transportation conducts (Figure 1). Vegetation monitoring includes vegetation height, plant composition density, invasive plant species presence, and blooming species abundance and diversity. These metrics were selected to study data significant to the upkeep of utility regulatory standards as well as ecologically relevant measures to inform sustainable management practices on utility ROWs.

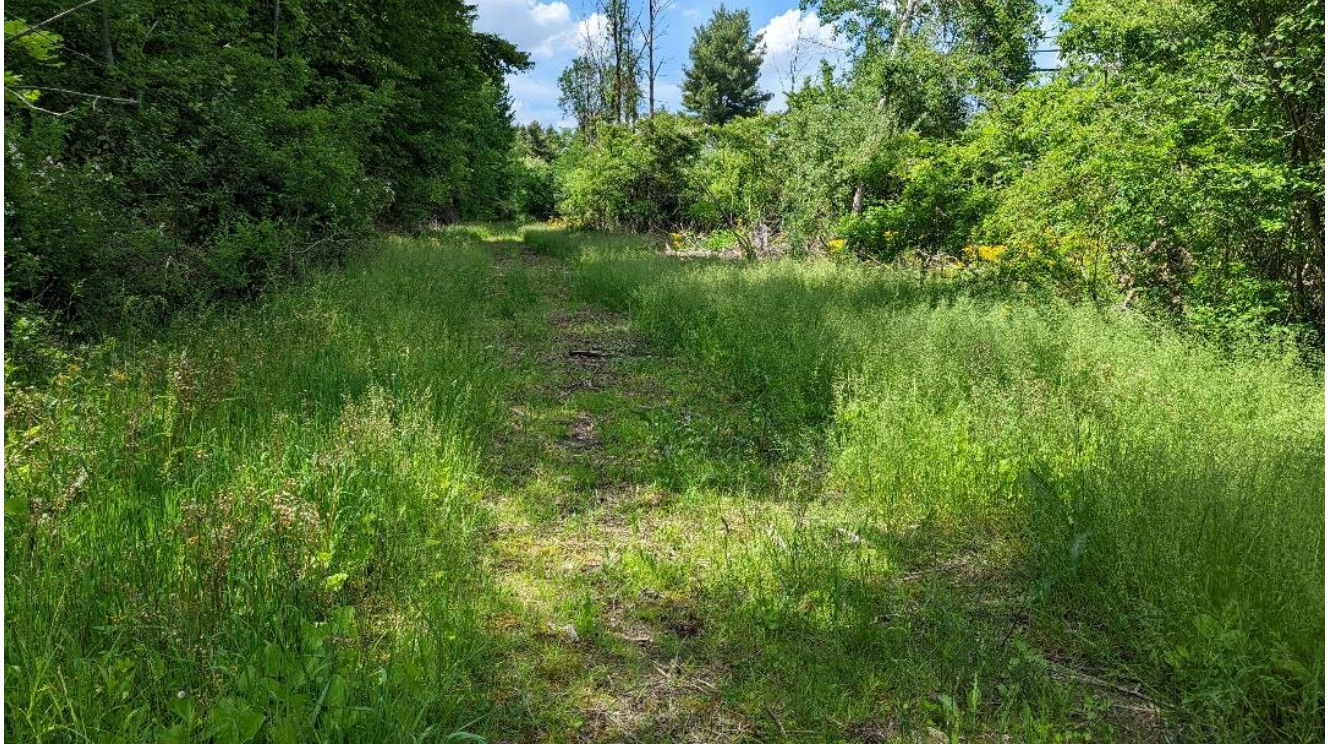
Figure 3. Zone B in May 2022, one year after cut-stump treatment highlighting the impact of the Plant Growth Inhibitor application over the pipe zone (Photo taken by Dr. Gabriel Karns on May 31, 2022).

Zones A and B represent more typical Integrated Vegetation Management (IVM) cycles than Zone C and are well suited for comparison. In 2021, maintenance for Zone A and B differed, with Zone A receiving a cut-stubble herbicide treatment, which was mowing followed by a low volume broadleaf herbicide application over the remaining stubble. Zone B received a cut-stump treatment which targeted woodies through the cutting of individual trees and applying herbicide to the stump. Cut-stump (Zone B) is only feasible in areas with a low density of woody plants that tend to be larger in diameter, versus cut-stubble (Zone A) which is better suited for areas with denser, smaller diameter woody plants. Of the 2 treatments, cut-stump is the more selective method. Both Zones A and B had PGI applied to the pipe zone, the section of ROW directly over the underground pipe structure, which is done to prevent root interference and stifle vigor of plant growth (Figure 3).

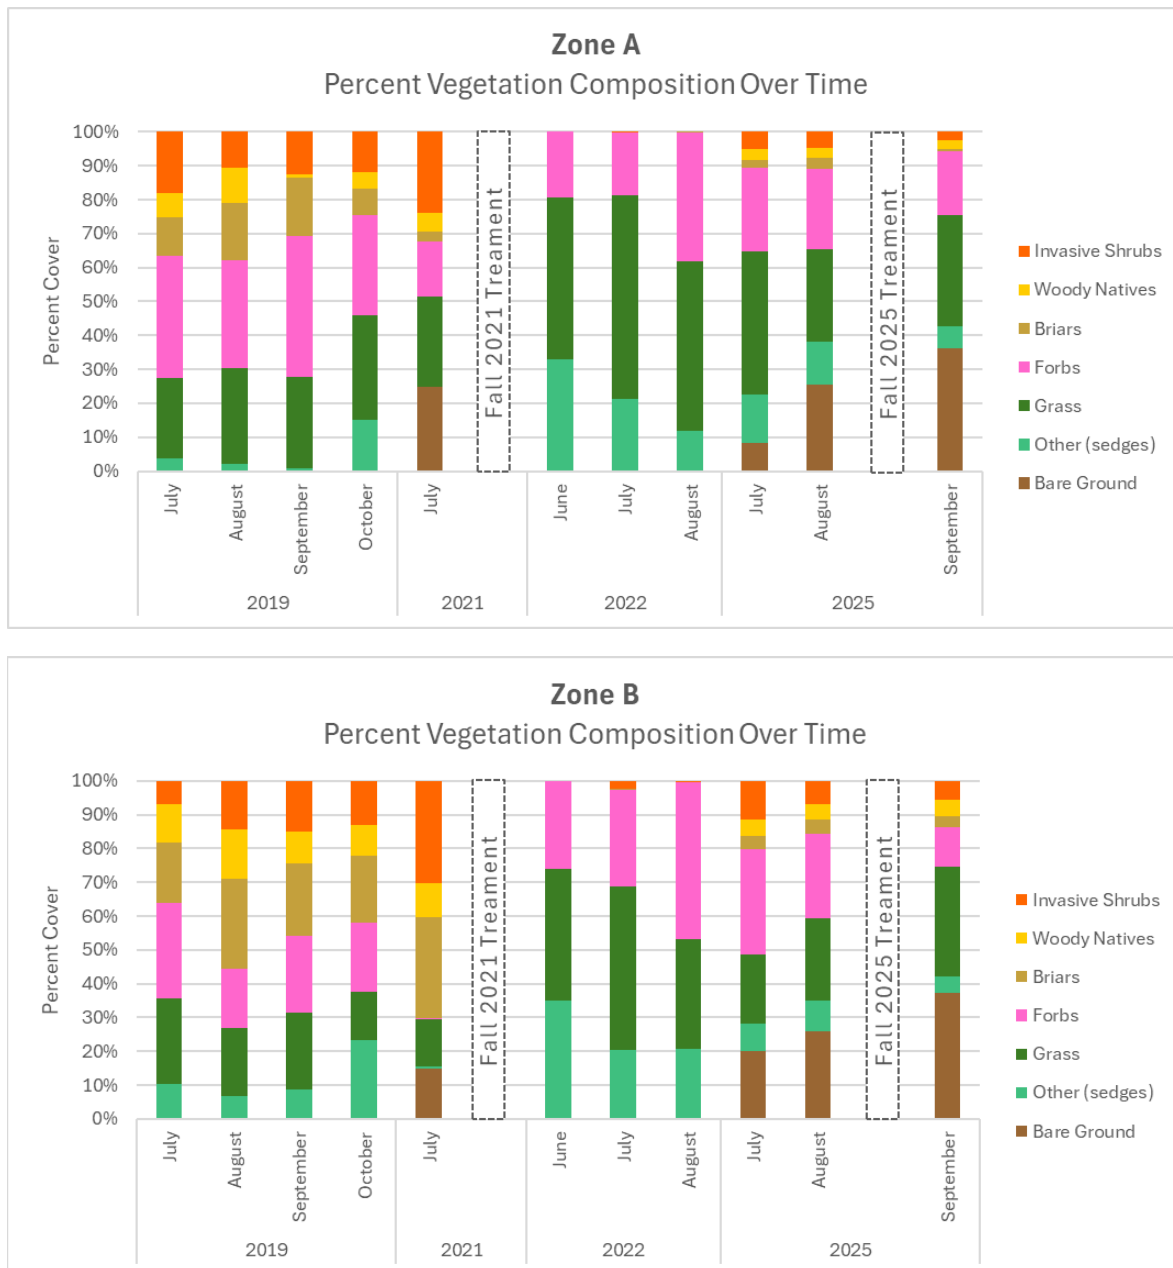
Figure 4. Percent vegetation cover composition of Zones A & B from 2019-2025.

In July 2021, both zones were composed of similar vegetation categories (Figure 4). Following the autumn 2021 treatment, compositions shifted in both zones – all woody plants drastically decreased and were replaced by forbs, grasses, and sedges. In Zones A

and B, the initial shift in 2022 favored grasses over forbs. The degree to which grasses remained dominant influenced how much bare ground was present in more recent surveys. Zone A, which retained grass cover above 40%, did not possess much bare ground, whereas fewer grasses correlated with a corresponding increase in bare ground for Zone B.

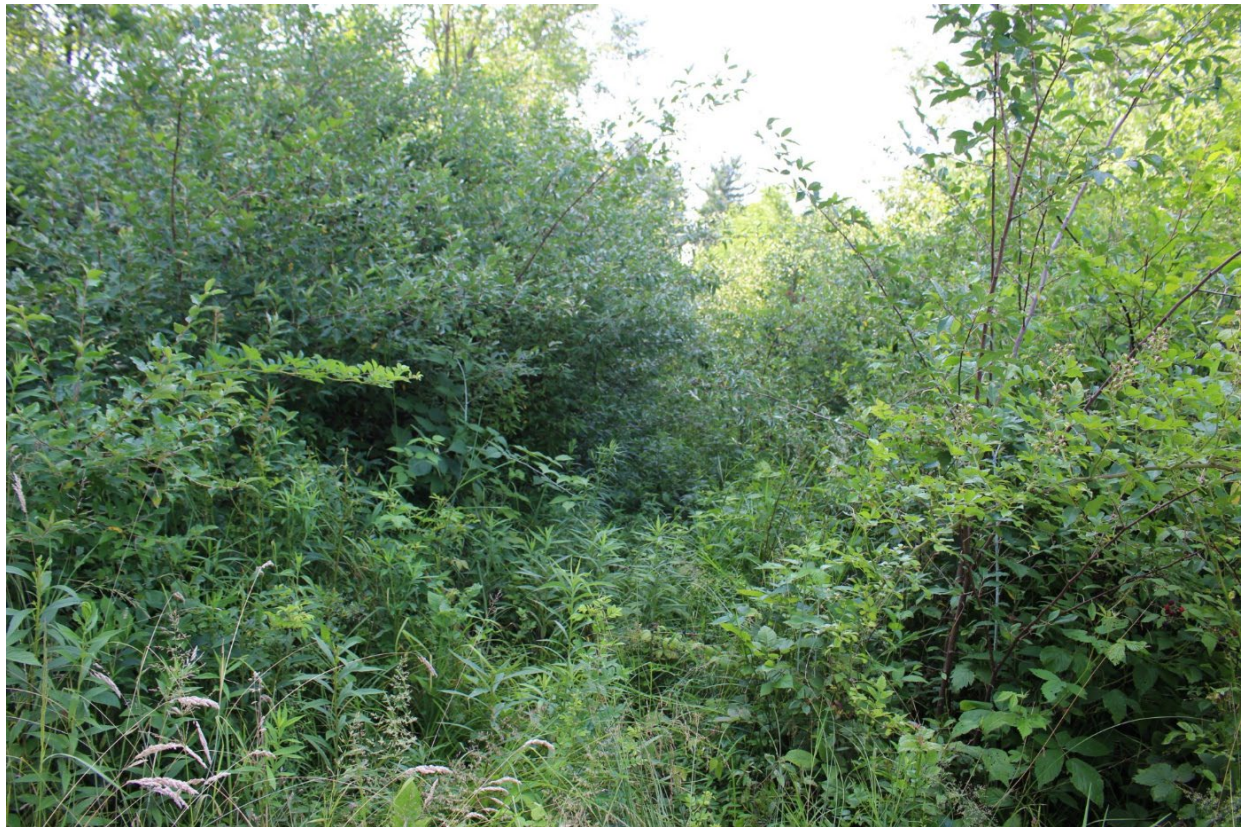
Figure 5. Zone C “entrance” in June of 2024, three years after mulch-and-grind treatment with no herbicide follow-up (Photo taken by Dr. Gabriel Karns on June 25, 2024).

Zone C has been continually overwhelmed by autumn olive, so much so that prior to management in 2025 (and even more so in 2021), to navigate through this zone a person had to crouch below branches arching over the narrow pathway in the center of the ROW as they ducked and weaved through a dense thicket (Figure 5). The few openings within Zone C were often inhabited by poison hemlock (*Conium maculatum*), creating significant access and navigation obstacles for leakage inspectors. In 2021, Zone C received a mulch-and-grind treatment, which consists of utilizing a skid steer with a forestry mulching head

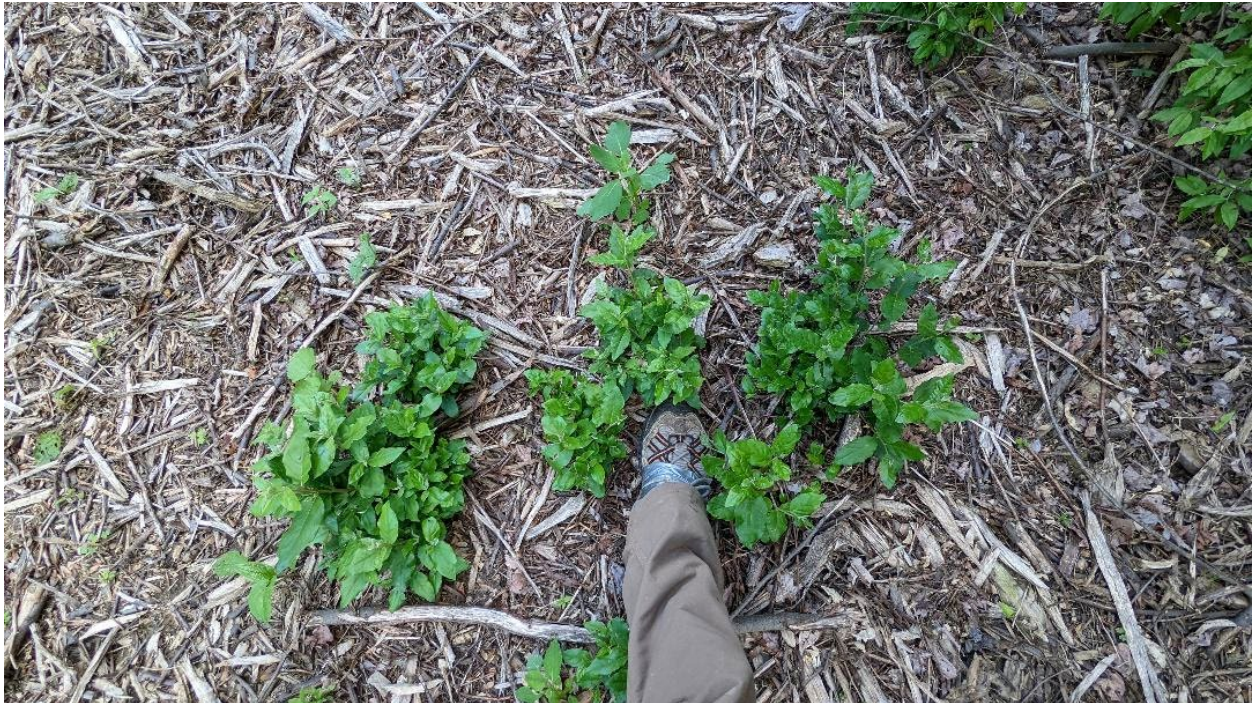
Figure 6. Zone C in May 2022, in the spring following the 2021 mulch-and-grind treatment, showing autumn olive stump sprouts that did not receive follow-up herbicide treatment (Photo taken by Dr. Gabriel Karns on May 31, 2022).

to eliminate most vegetation, essentially restarting secondary succession (Figure 6). A follow-up foliar herbicide treatment was planned to control incompatible woody resprouts, but budgetary constraints prohibited follow-up activities, and the planned herbicide treatment was deferred. By 2025, Zone C had returned to a dense thicket of autumn olive, requiring a similar reclamation approach (Figure 5). Reclamation is a term reserved for especially intensive vegetation treatments to get a site back into compliance from a state of serious non-compliance.
